**BASS LAKE DAM**

**NJ 00271**

**PHASE 1 INSPECTION REPORT**  
**NATIONAL DAM SAFETY PROGRAM**

May, 1979

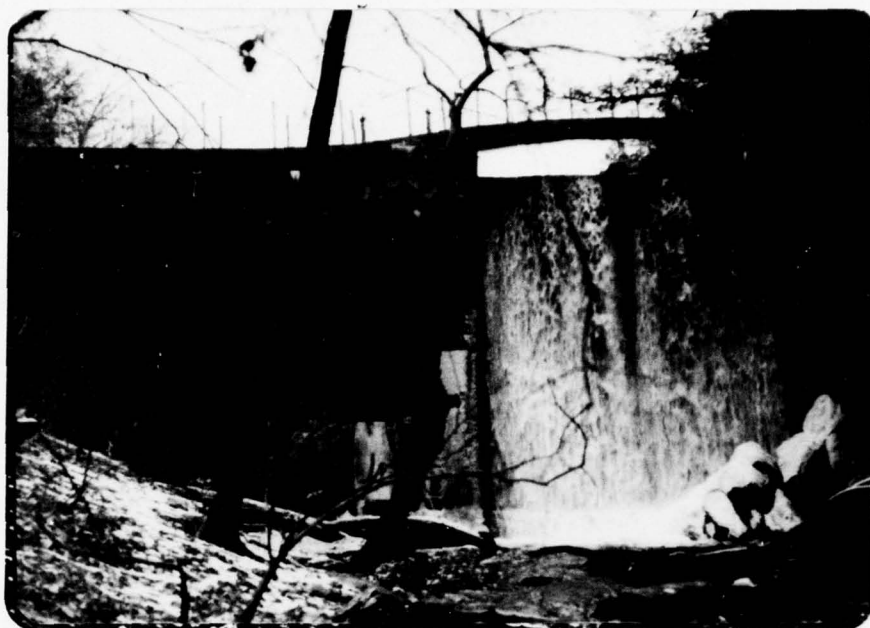
Downstream right face of  
dam and spillway. Looking  
upstream.

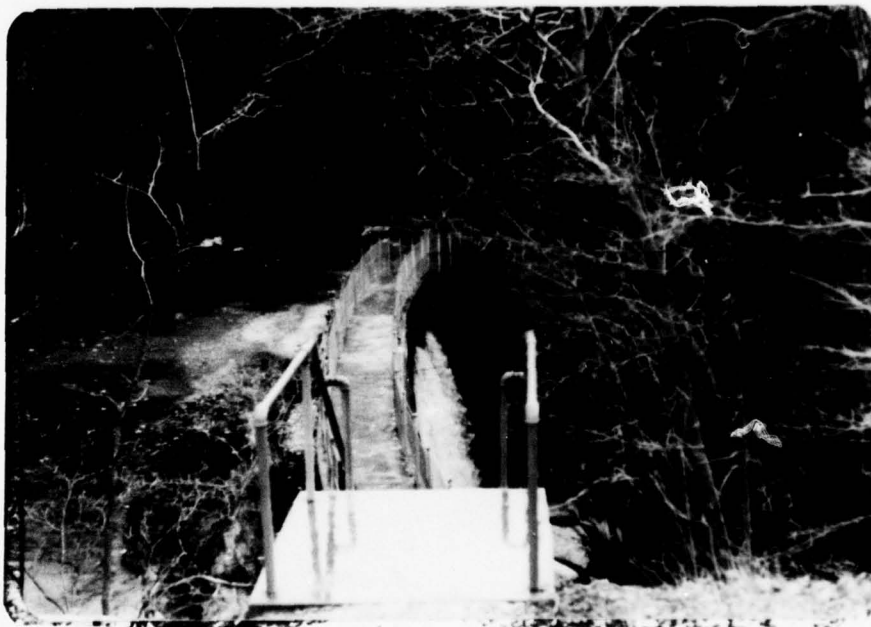
View along crest of dam.  
Looking from right abutment.

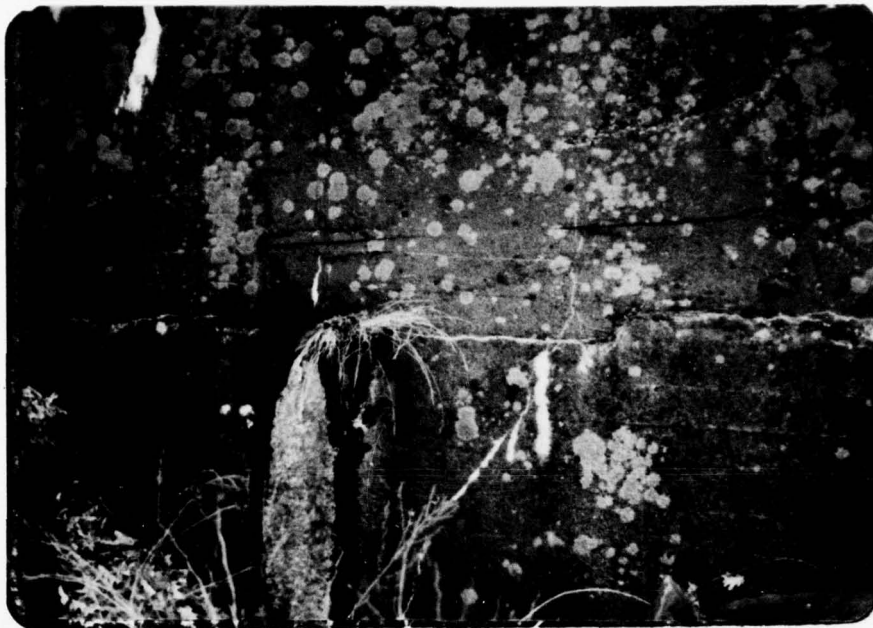
Water leaking through face  
of dam at right side of  
spillway.

(2) Repair spalled and deteriorated concrete and completely plug leaks through the dam.

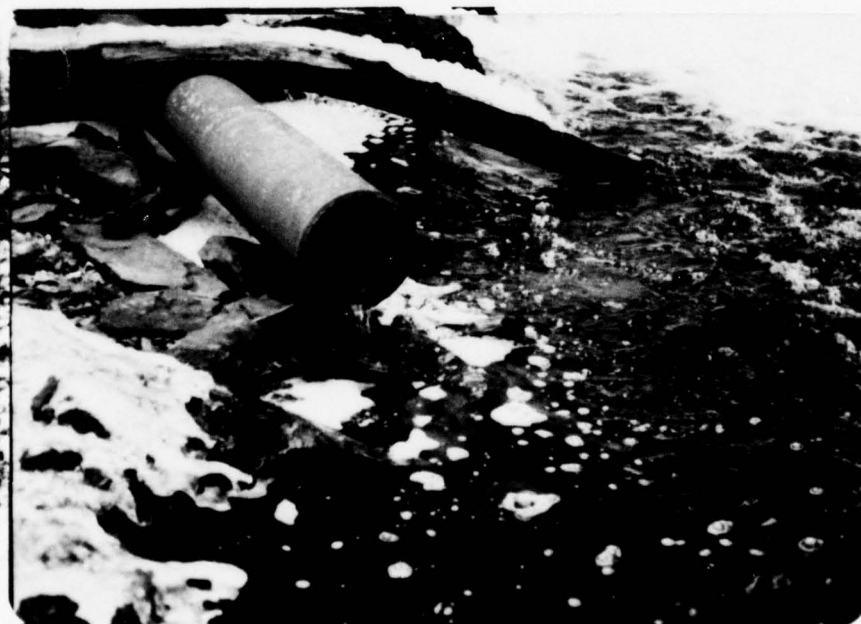
12-in-dia outlet pipe.  
Outlet pipe is below tail  
water.

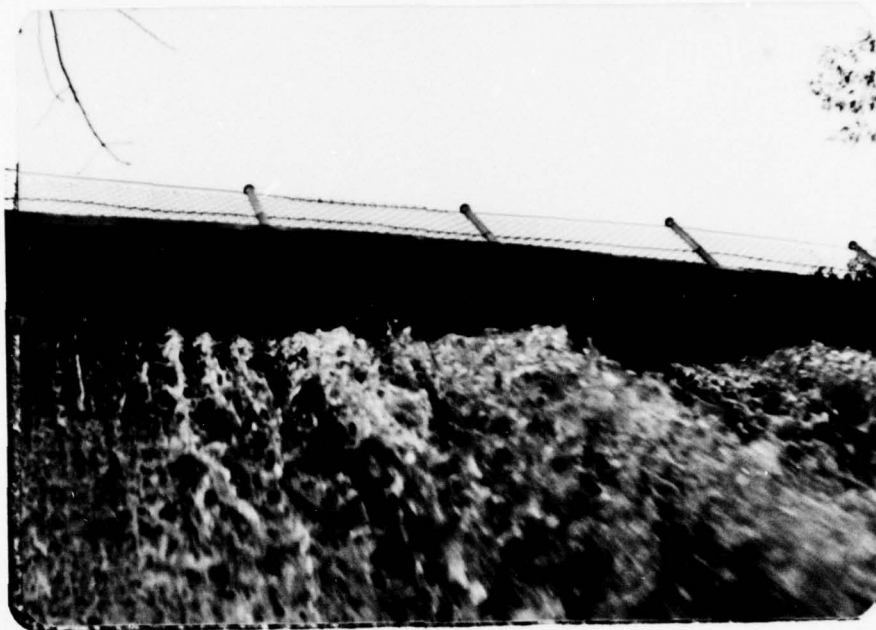
Spillway crest below foot  
bridge.

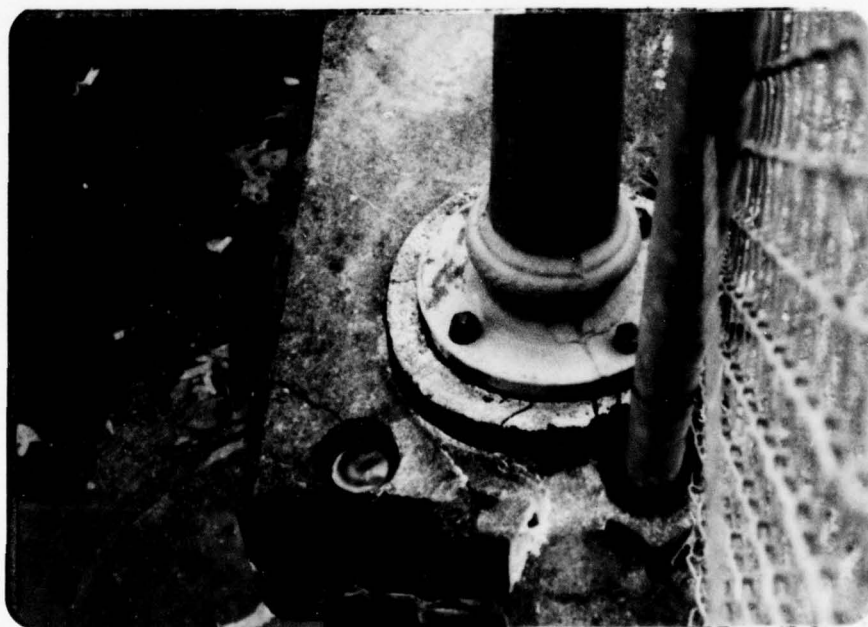
The gates for the 12-inch and 18-inch outlet pipes, which are located at the base of the upstream side of the dam, are operated by two control stems which extend up to the top of the dam. All gates were known to be closed at the time of our inspection. Yet, a small quantity of water was observed discharging from the 12-inch-dia pipe. The superintendent did not know whether or not the gates could be closed once they were opened, consequently, they were not operated. The concrete headwall for the two outlet pipes has deteriorated badly. Concrete support for the gate operators has cracked.

Concrete cracked under  
gate valve operator.

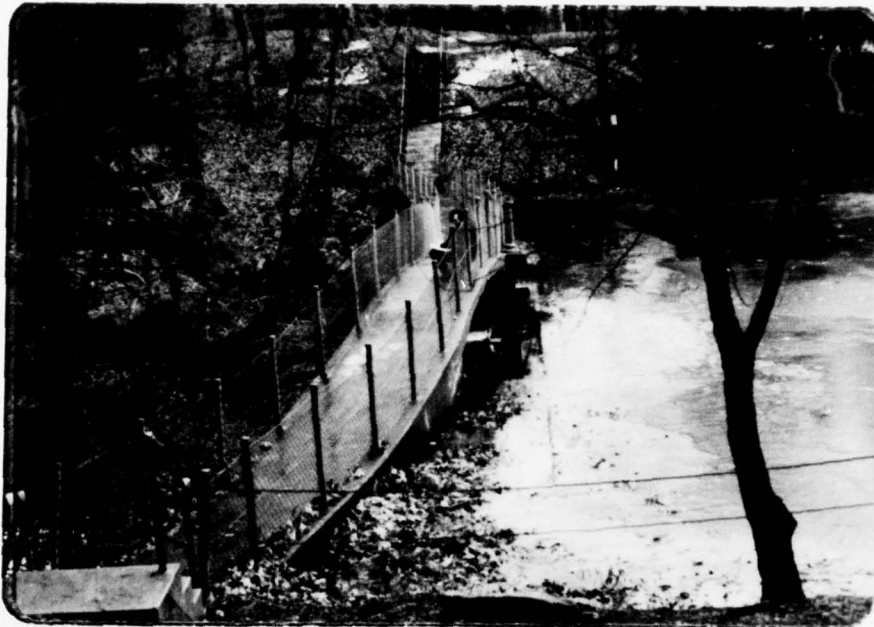
Crest and upstream area  
looking from left abutment  
of dam.

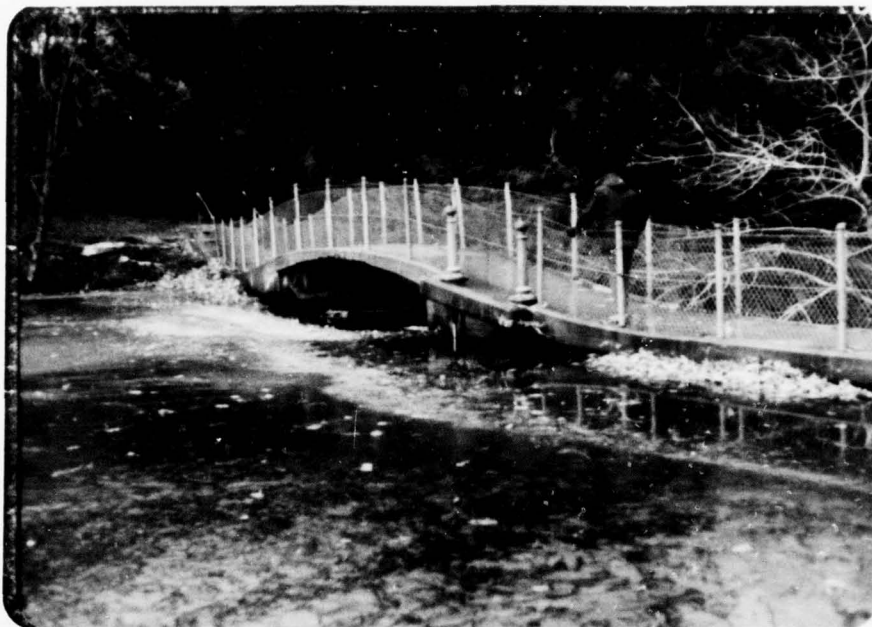
View of upstream crest of dam and gate valve operators. 21 December 1978

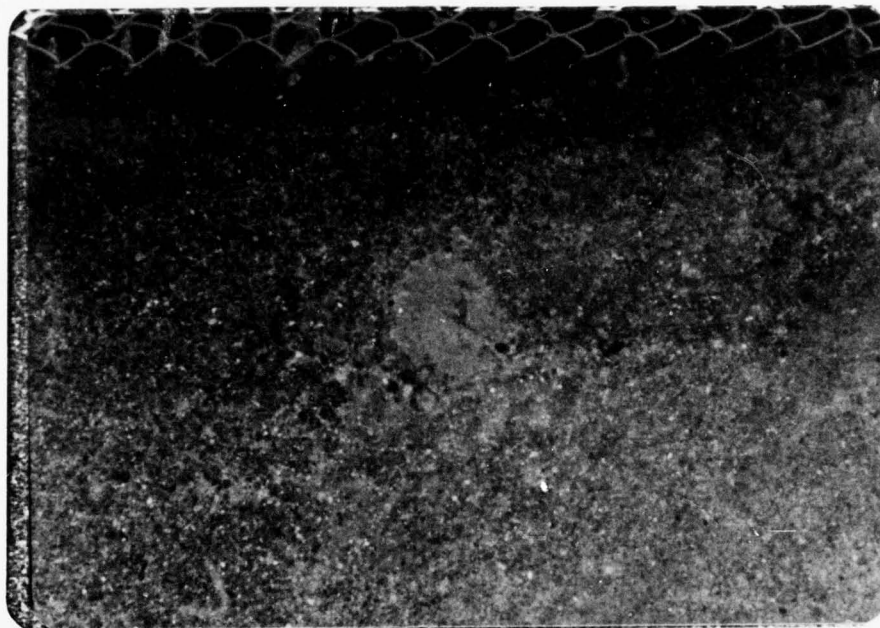
Patched grout hole at top  
of dam.

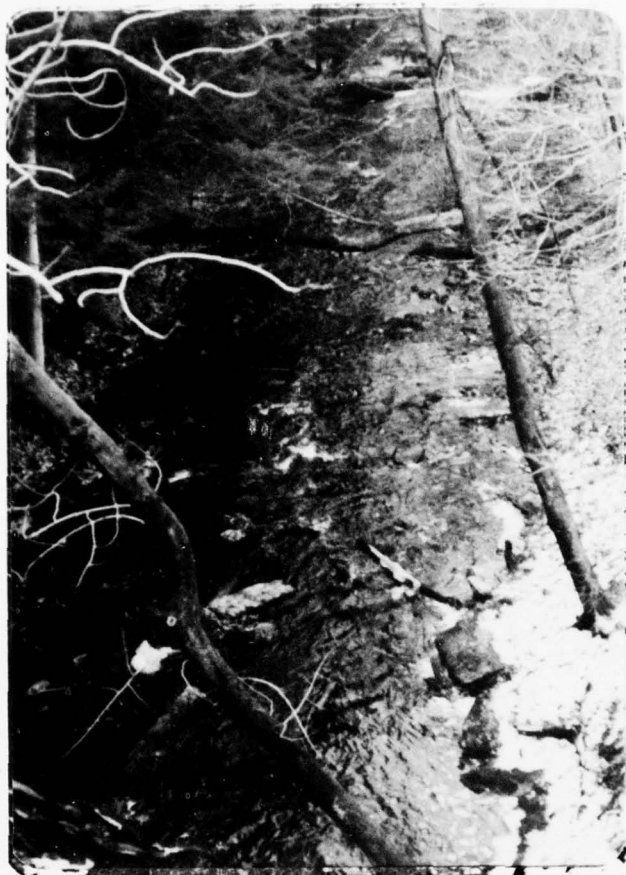
Downstream discharge  
channel viewed from foot  
bridge.

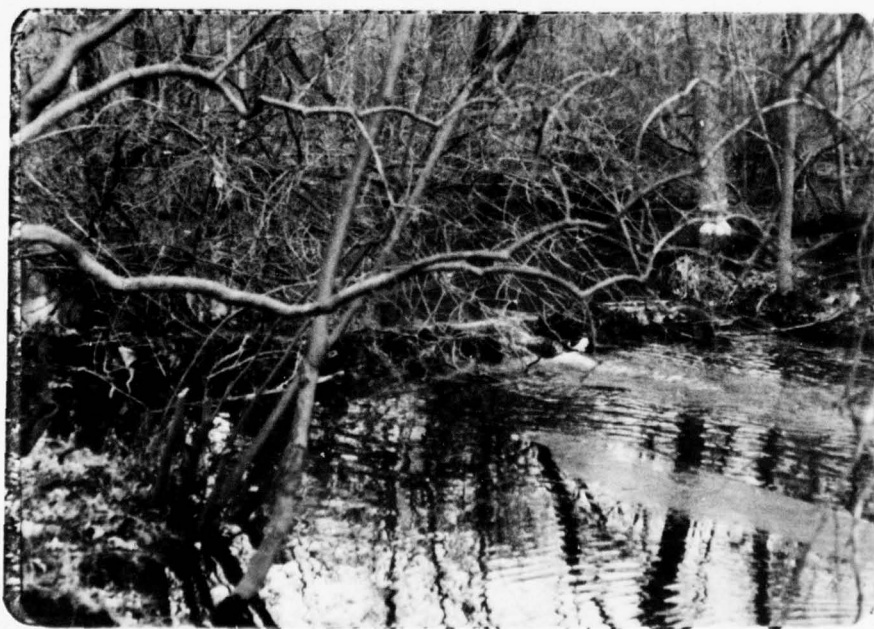
Beaver dams upstream of  
inlet stream to Lake.

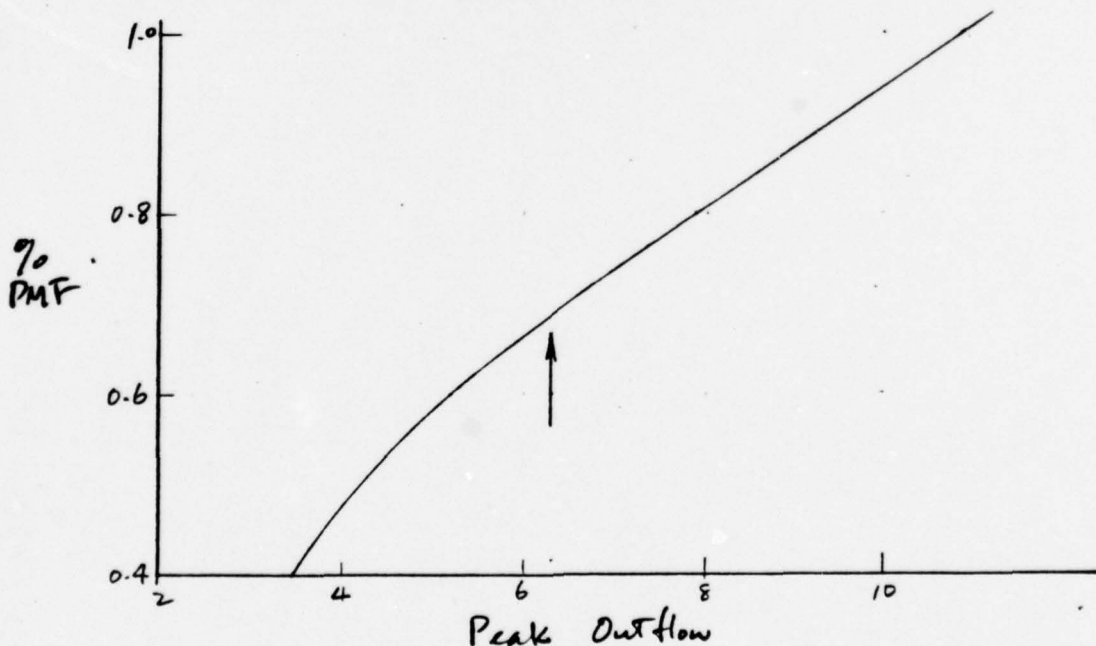
3. Dam overtops at approx. El. 101.1 with  $Q = 63$  cfs  
 $\therefore$  dam can pass approx. 0.7 % of PMF.
